Inspection Report

???? Santa Fe Drive
Overland Park , KS
66204

Inspection date: 10/19/2015

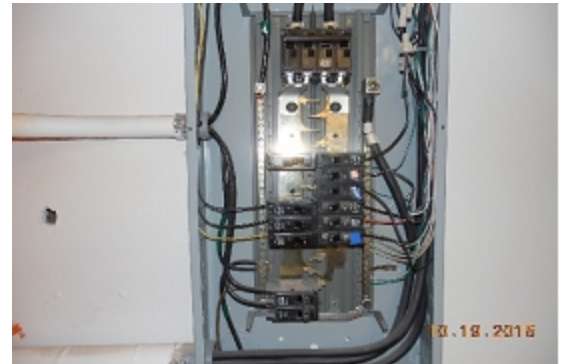
Rated at 200 A and is located in the break room at the southeast corner

Breakers: 10-20 Amps, 1-100 amp breaker is a disconnect to the Sub-panel

Note Top left 20 amp breaker is unused.

* There is a service disconnect located next to the water heater which has fuse cartridges. This service disconnect is for the air-conditioning condenser on the roof.

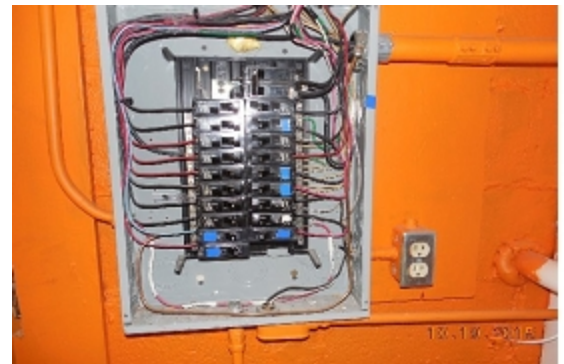
Rated at 100 Amps and is located in the break room at the southeast corner area.

Breakers: 19-20 amp's

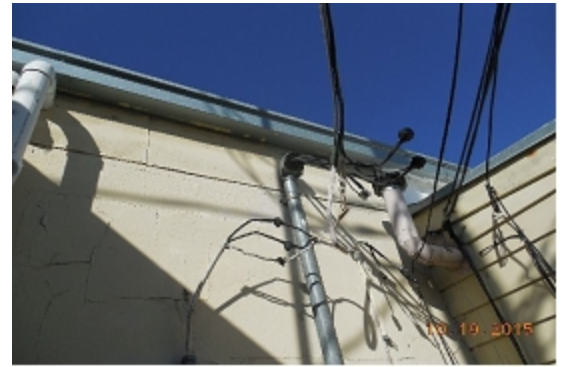
The electrical service is overhead from a transfer to the electrical mast at the building and then to the electric meters

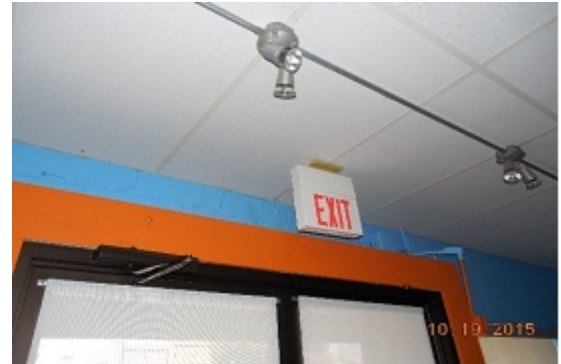
Unit 7905 has a lighted exit sign present at the front door.

1. There should be a Lighted Exit Sign located inside the front door of Unit 7907 and also one at the rear pedestrian door at the break room.

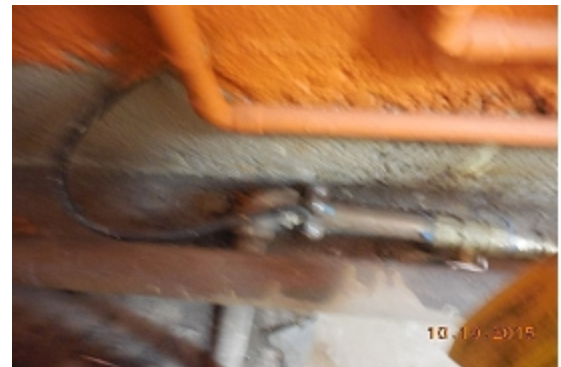
The main electric panel is grounded to the main water line where the water line comes in through the foundation next to the main water shut off valve.

The subpanel is grounded to the conduit connected to the main electric panel.

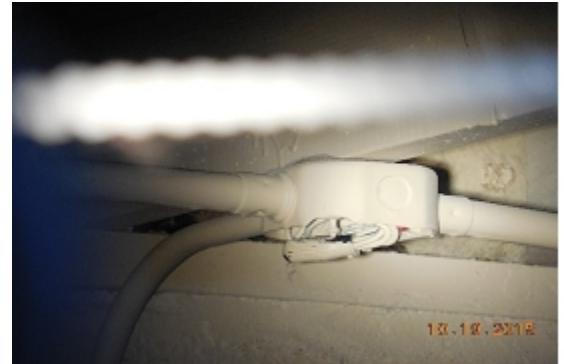
** This picture is of Unit 7907, north west corner of of the ceiling tiles is an electrical junction box that need to cover installed.

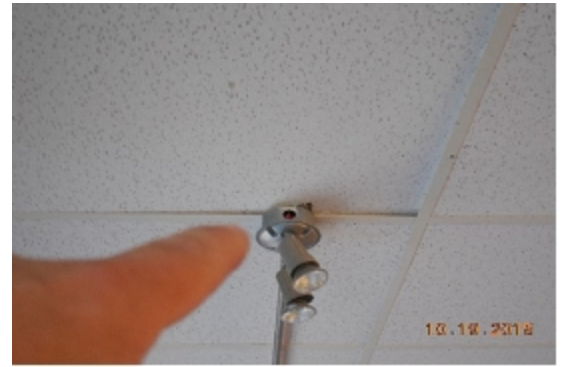
Unit 7905, the first light bar just inside the front door has the junction box at the south end that is missing a knockout plug.

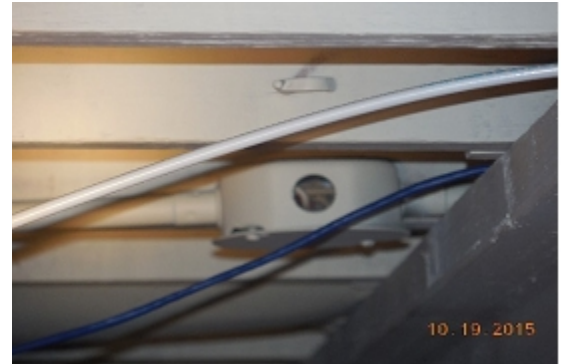
Unit 7905, above the ceiling tile at the east center column on the east side is a junction box missing a knockout plug.

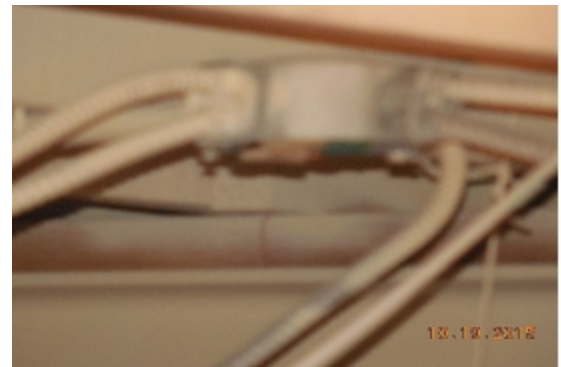
Unit 7905, above the ceiling tile at the West center column on the east side, there is a junction box it is missing the cover.

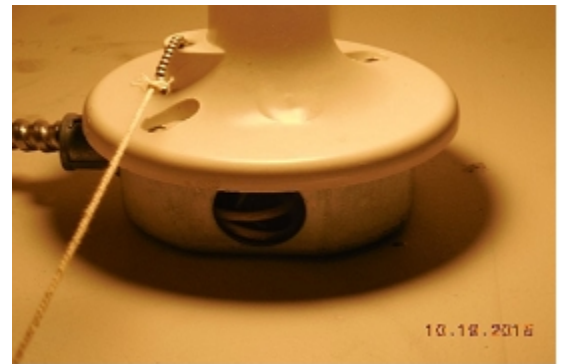
The light fixture inside the furnace room is missing a knockout plug

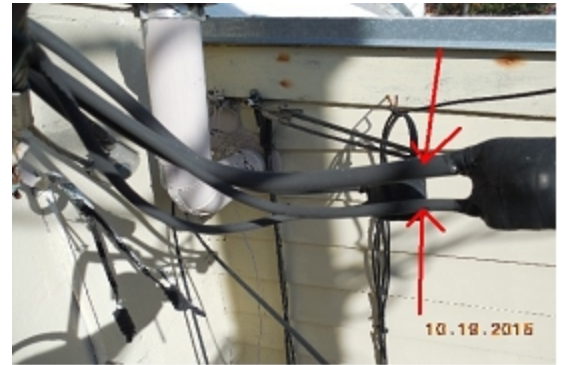
The exterior electrical service cable from the utility transformer to the building connection only appears to be a 100 amp capacity cable. The electrical service cable from that connection to the electric meter and into the building is a 200 amp cable. Need to contact KC P&L and have them review the service to make sure that it is adequate from the transformer or if it needs to be upgraded to a larger size cable.

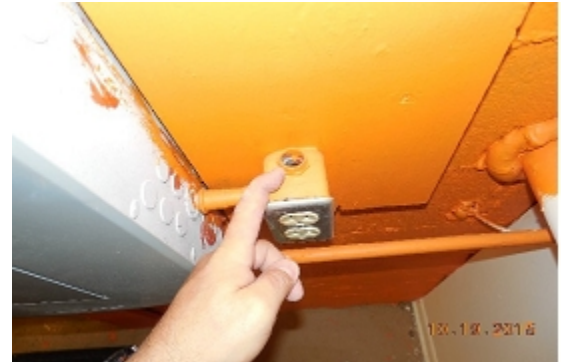
There is an electrical receptacle at the right side of the subpanel that has a unused connector at the top it needs to be removed and a knockout plug installed.

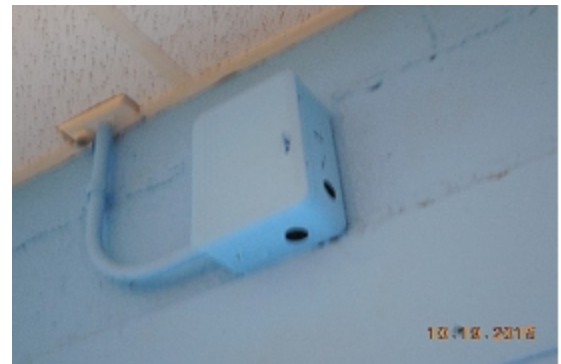
Unit 7905, above the front door area are 2 electrical boxes with open knockouts that need to have knockout plugs installed. There is also a junction box in this area that has a missing knockout that needs a knockout plug installed. There is also an orange light switch junction box that has a double switch cover but only one switch so there is one side that is open and should be properly sealed and tape is not acceptable.

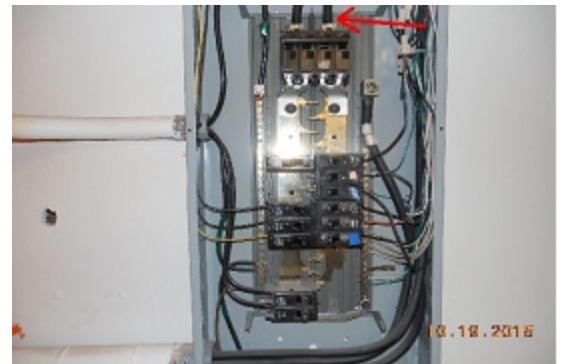
The service entrance cable inside the main electric panel is a #4/0 Aluminum 200 amp cable.

The electrical service to the building is a Single Phase System.

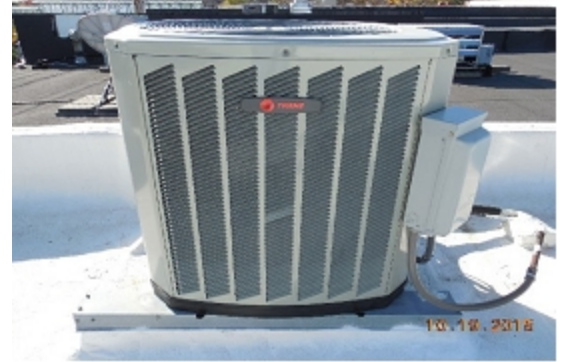
Brand: Trane; Model # 4TTA3060D3000CA, Serial # 14184RXD4F, 5 ton capacity unit

Age: Manufactured in 2014 and the average life expectancy is 17 to 20 years.

Owner Maintenance: 1. The air conditioning condenser can only be a maximum of 15° out of level, so monitor yearly and correct when needed. This is a roof mounted unit so unless the roof has an issue this should not be a problem. 2. Flush out and clean the air conditioning condenser cooling fins monthly when in use. Since this is a roofmounted unit it may only need to be done a couple times during the season.

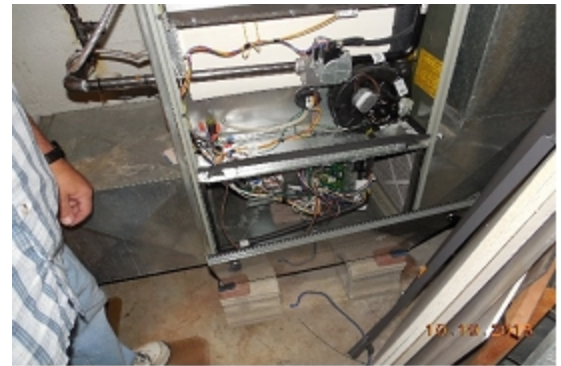
Brand: Trane; Model # TUH10120A9H51BA, Serial # 14033UHX7G, 110,000 BTU gas input

Age: Manufactured in 2014, average life expectancy is 17 to 20 years.

Air filters: TWO- 1 x 16 x 20 and these filters need to be replaced monthly with a quality pleated air filter.

1. These air filters need to be replaced now.
2. There are areas above the furnace at the air conditioning evaporator area that has air laws and should be taped and sealed with stainless flex tape.

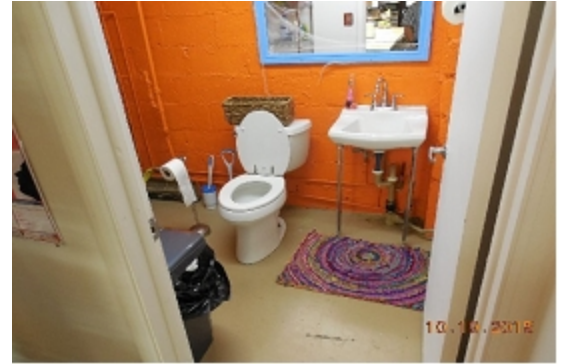
Restrooms: Two Half Bath's

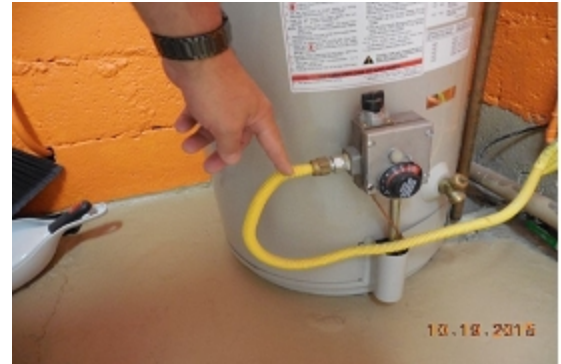
1. The water heater gas supply line must have a Drip Leg installed before the gas enters the gas valve of the unit. (Between the yellow gas line in the gas valve)

2. The exterior hose spigot located on the east side of the building below the electric meters is dripping.

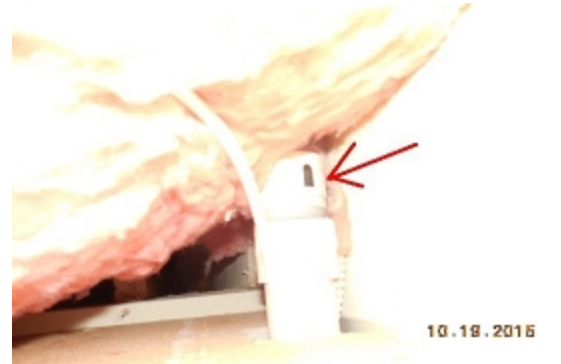
There is also a vent pipe for the breakroom sink and ice machine that stops above the ceiling tiles and has a check valve installed. This is acceptable when the event is only for a sink.

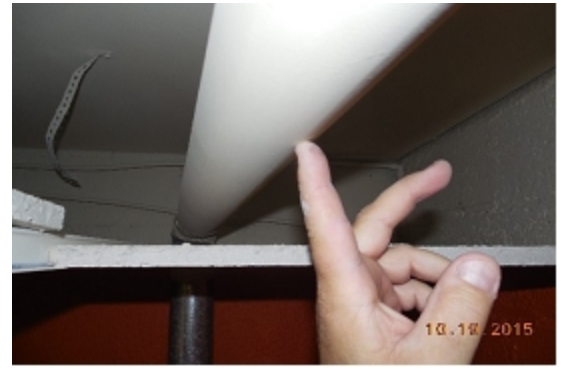
This picture is of the water heater flue pipe above the ceiling tile area. You can't see the downward slope of the pipe in the picture that you can get your head up above the ceiling tile look at the pipe

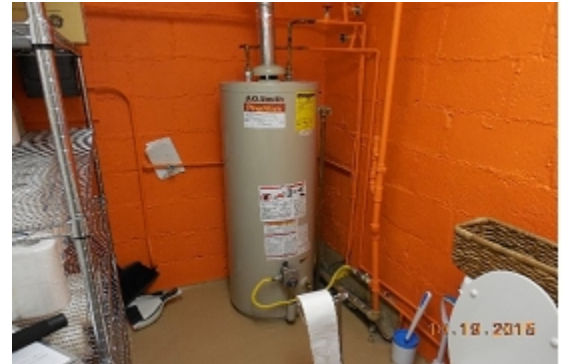
AO Smith Water Heater: 40 gallon gas unit

Age: 12 years old and the average life expectancy is 12 to 14 years

1. The water heater flue pipe above the ceiling tiles angles downward and then angled back up and goes through the wall into this furnace room. The flue pipe is supposed to have a continuous rise in the pipe. I know that the height above the ceiling is small but it appears that this can be improved. Improper slope can cause a lack of proper draft which can push carbon monoxide back into the restroom area at the water heater.

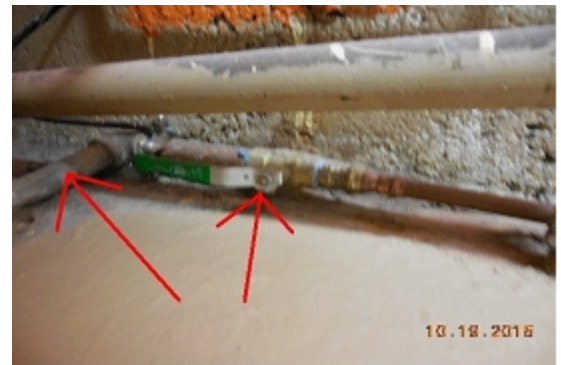
Main water piping: Galvanized piping

Main water shut off valve location: South restroom at the floor to the south side of the water heater and it is a ball valve

1. Galvanized piping has a life expectancy of 40 to 50 years. It is recommended that the main service water pipes be evaluated.

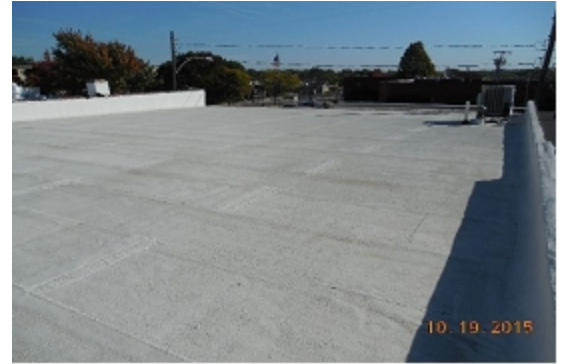
The roof covering material appears to be rolled asphalt with a mop on type white roof sealant.

The roof covering material appears to be in good condition and should be checked approximately five years.
