RC Certified Inspections

Inspection Report

???? W. 117th St.
Leawood , KS
66211

Inspection date: 9/14/2015

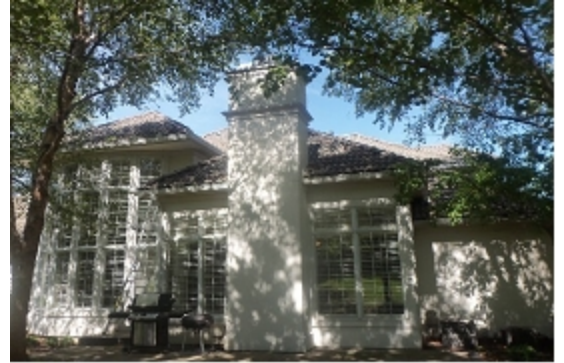
1. The soffits have narrow soffit ventilation, but most of it has been painted over.
2. There is mold growth on the surface of the soffits basically on all sides of the home which is normally an indication of improper soffit ventilation or soffits filled with insulation.

* I recommend that the soffit vents be removed to inspect the soffits and either blow out or clean out soffits and install new vents.

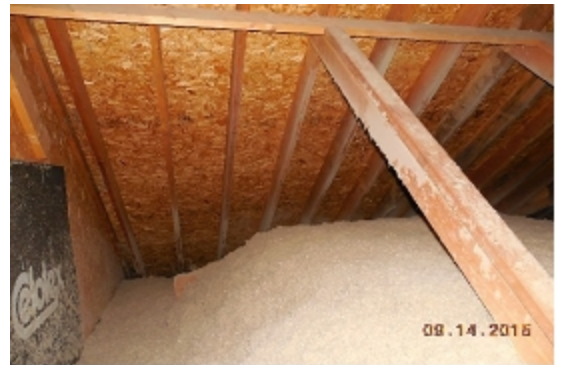
1. There is damaged and missing vertical wall insulation in the attic area above the master bedroom bath area.

2. The attic appears to have all blown in Cellulose insulation. I cannot tell if all the insulation was completely vacuumed and removed from the attic prior to installing this insulation. I am recommending that you receive documentation from the insulation company regarding what work was done in the attic.

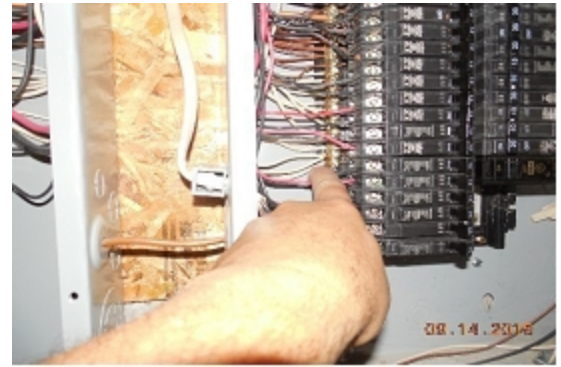
1. Loose receptacles and or light switches at the wall boxes at: East bedroom East wall, Office south wall, Master bedroom West closet light switch, basement between the stairs in the TV area,
 2. Master bedroom bath whirlpool tub wall GFCI is missing the to screws for the cover.
 3. Receptacle at the southeast side of the wet bar is not grounded.
 4. The smoke alarm above the water heaters is hanging by its wires.
- * The receptacle at the kitchen island is not GFCI protected. It is more than 6 feet from the sink or any other wet areas.

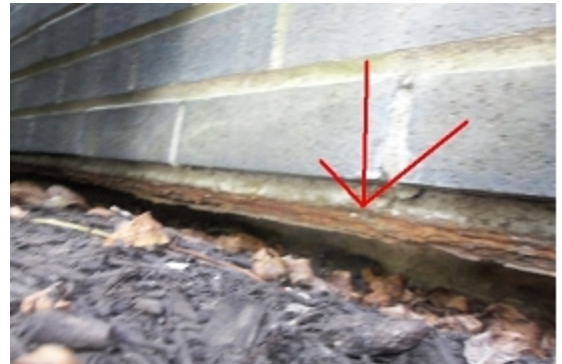
3. There is a metal lentiil under the brick which is the brick support in this metal lentiil has been rusting and the metal is swollen. There may need to be future repairs needed at this brick lentiil.

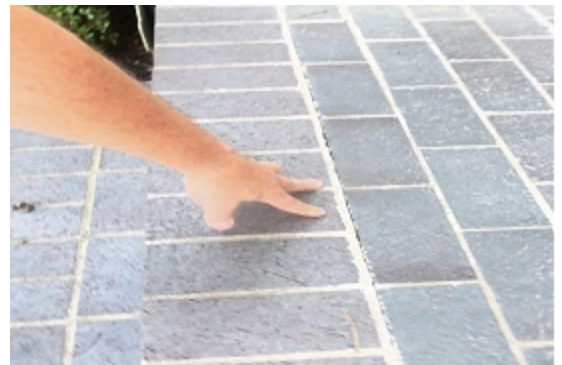
1. There are several of the brick mortar joints that need to be cleaned out and repaired (top pointing). There are cracked and open mortar joints and fungi growing through the mortar joints.

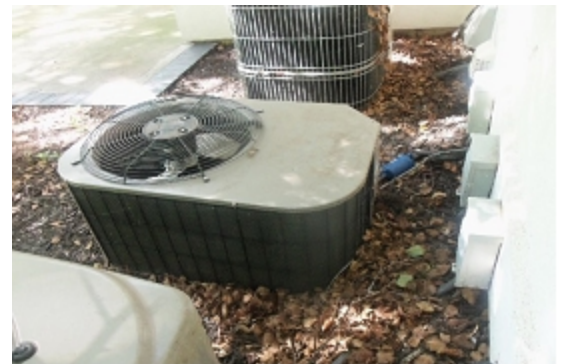
1. The air-conditioning condenser is more than 15° out of level and needs to be corrected now.

2. Need to flush out the air conditioning condenser cooling fins

3. All of the air conditioning condenser refrigerant lines on the exterior needs replacement of the insulation wrap.

5. Make sure that the mulch and ground covering around all the air-conditioning condenser's are lower than the bottom hands of the condensers. Right now it is too high at two of the air-conditioning condenser's.

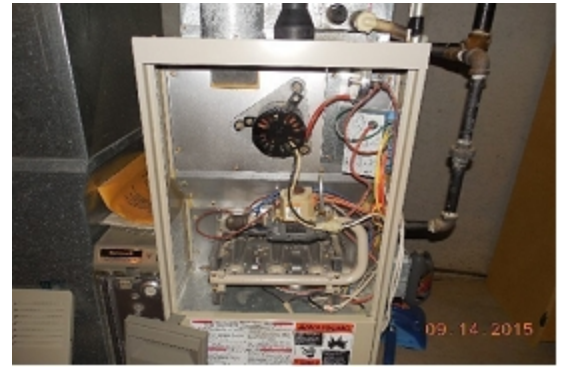
4. The flue pipe from this furnace where it connects with the other flue pipes is rusted out. This is a safety concern for carbon monoxide.
5. The flue pipe in the attic is rusted out at the elbow below the vertical pipe from the roof.

6. From the Sellers disclosure, there had been raccoons in the attic. Apparently the raccoons have destroyed the heating and air supply duct hoses that run between the main metal trunk line to each supply vent. The outer shell of these ducts and the insulation have been torn apart leaving only the inner thin liner and most of them that was visible has holes through them. All of the supply flexible insulated ducts in the attic need to be replaced now.

8. There is water staining and rusting in the furnace compartment at the burners and the blower area. This is caused by overflowing or a rusted out evaporator condensation drip pan. Continuous leakage onto the heat exchanger can cause cracks in pinholes.

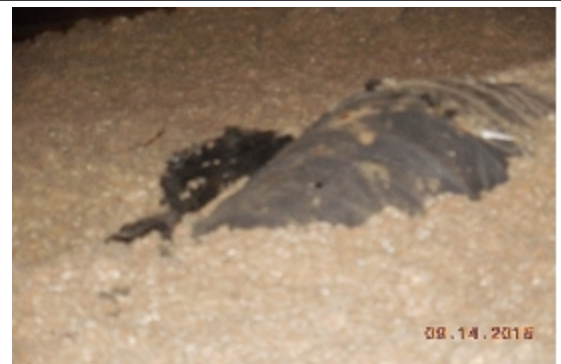
From the Sellers disclosure, there had been raccoons in the attic. Apparently the raccoons have destroyed the heating and air supply duct hoses that run between the main metal trunk line to each supply vent. The outer shell of these ducts and the insulation have been torn apart leaving only the inner thin liner and most of them that was visible has holes through them. All of the supply flexible insulated ducts in the attic need to be replaced now.

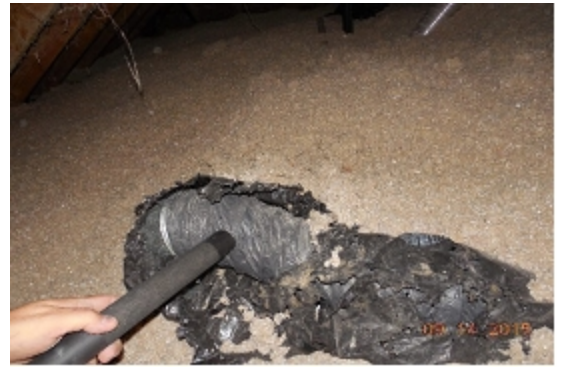
The attic main ductwork is insulated and there are several areas where this installation has been torn off by the raccoons, so this ductwork needs to be properly re-insulated.

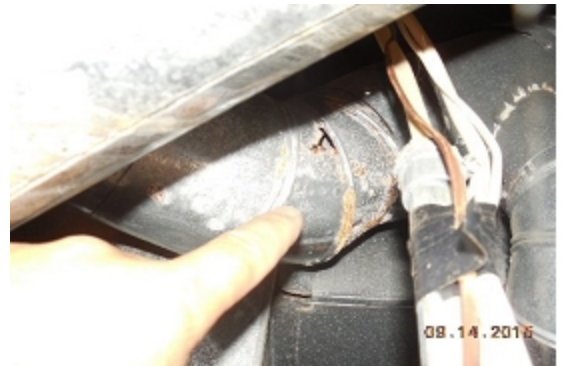
Rusted flue

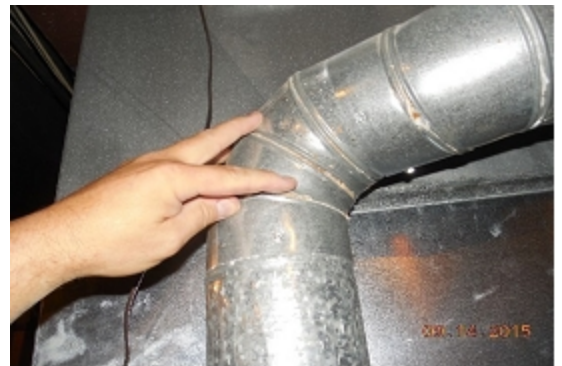
The flue pipe in the attic is rusted out at the elbow below the vertical pipe from the roof.

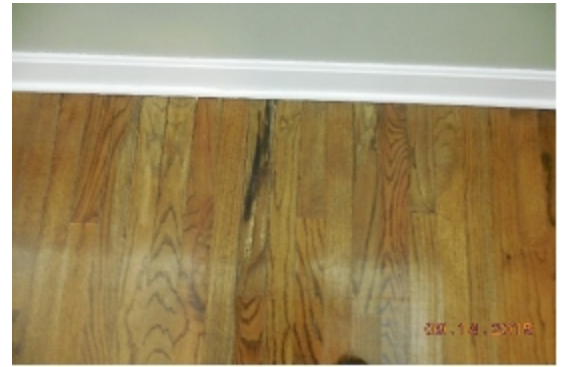
1. There are several cracks throughout the tiled floor in the foyer area and dining room area.
2. There is water damage to the hardwood flooring at the hearth room exterior pedestrian door area. I also noted water damage to the subfloor below this area.
3. There is water damage to the hardwood flooring in the hearth room at the west wall which is an approximate 2 ft.² area.
4. The hardwood flooring throughout the hearth room into the kitchen area is badly warped due to elevated humidity in the basement. Once the above noted repairs are done, then the entire floor will need to be sanded and refinished.

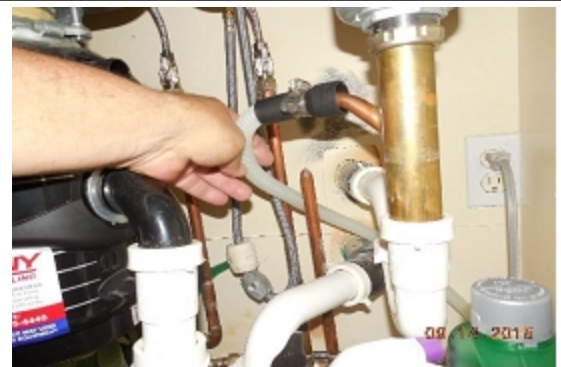
1. The dishwasher drain line does not have an air loop in the line. What this means is, the drain line is supposed to enter at the bottom shelf area under the kitchen sink and immediately run up to the bottom surface of the countertop and then create an 8 inch minimum loop in the line and then connected to the drain connection. This top loop in the drain line help prevent siphoning back into the dishwasher.

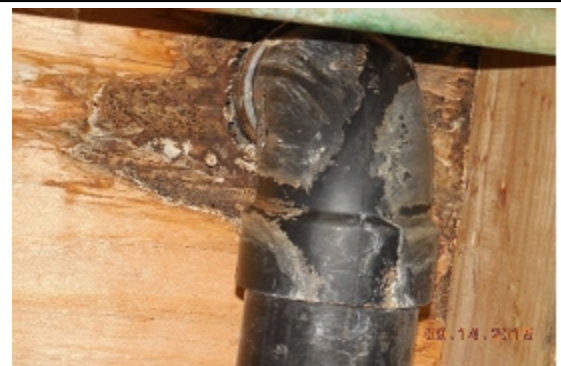
1. There is water damage to the subfloor under the half bath toilet area.
2. There is water damage to the subfloor under the hearth room exterior pedestrian door area.
3. There is water staining on the subfloor under the hearth room West wall area.

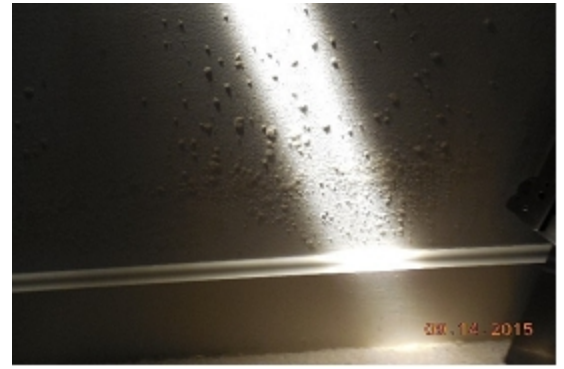
This is mold growth on the drywall surface in the basement bedroom closet area

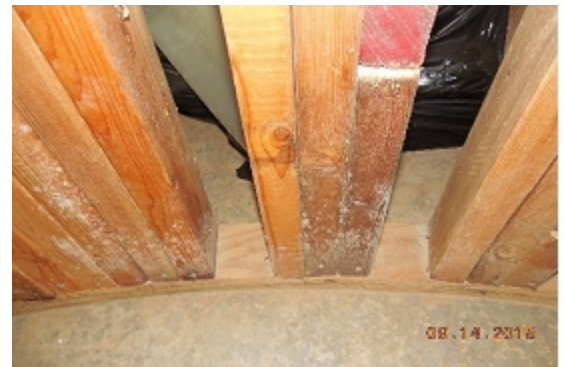
The white on these wall studs is mold growth

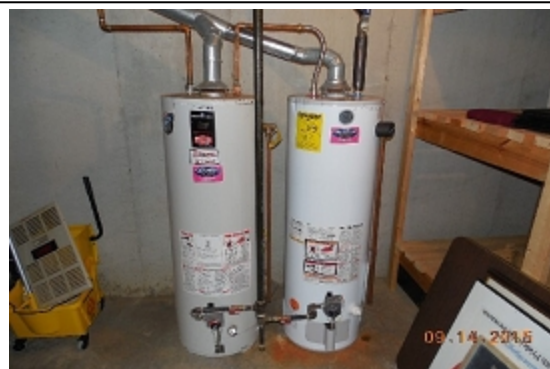
1. The Bradford White water heater is beyond the average life expectancy so this unit needs to be monitored. Replacement is recommended.

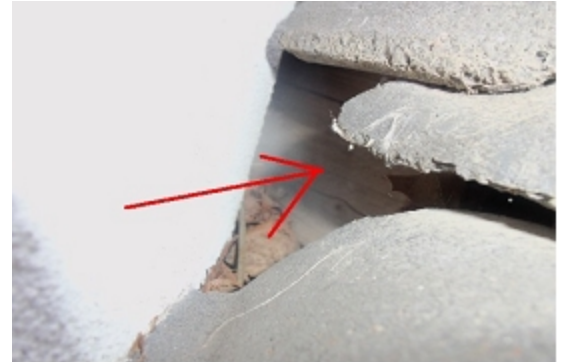
This picture is above the office/MBR area and there is wood visible under the roof tiles which appears that there should have been either flashing or underlayment material covering this area. A few of these tile would need to be removed for inspection.

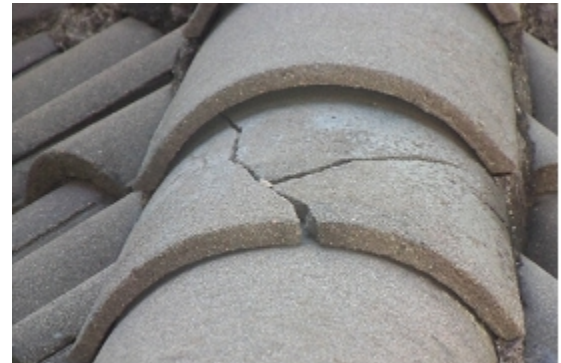
1. This damaged ridge Roof tile is located above the master bedroom bath area on the north side.
2. There are a few loose and shifted tiles in the same area.

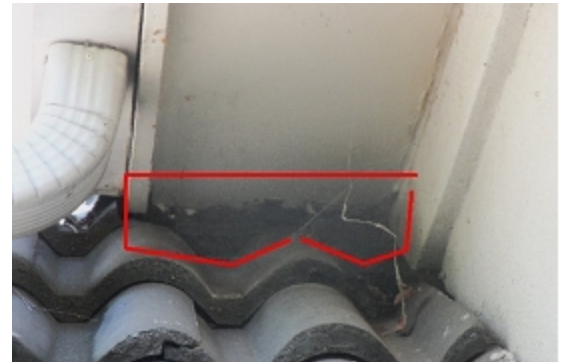
There are several areas where the soffit comes down and stops just above the roof tile surface. There has been wire fence material rolled up and pushed up underneath the soffit areas in these locations to keep rodents and birds out. I'm not sure if this is the best way to, but the proper way would be to install flashing attached to the soffit that runs down to the shingles surface that would be more rigid.

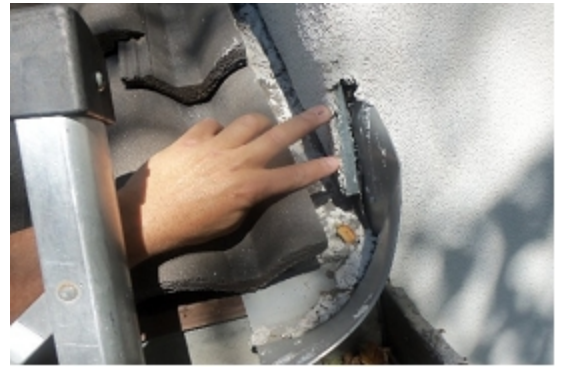
One in particular is on these now side living room area which is the picture at this location.

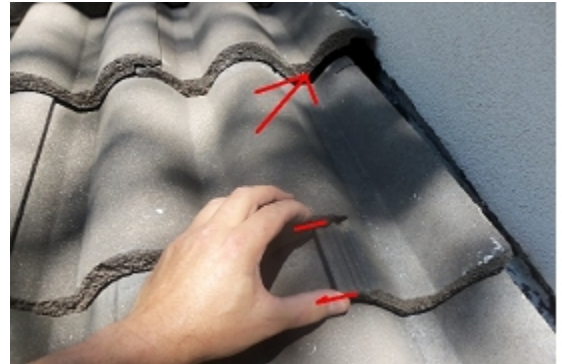
There are Several roof tiles that have slid down approximately 4 inches and some of these far enough that there is a gap at the top of the tiles. I know someone is been out here on the roof but someone needs to come out and really check the tiles and make needed repairs.

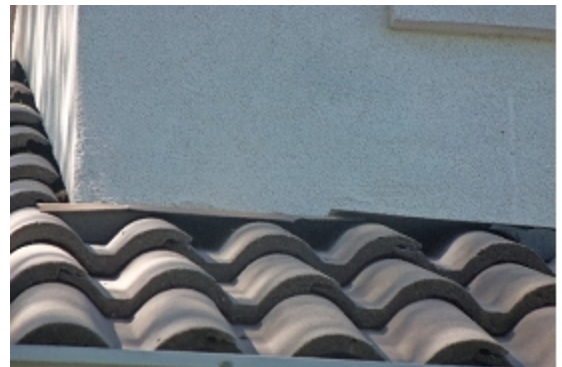
Roof tiles need to be checked on the Eastside at the East bedroom area and the flashing along the wall of the East bedroom needs to be corrected.

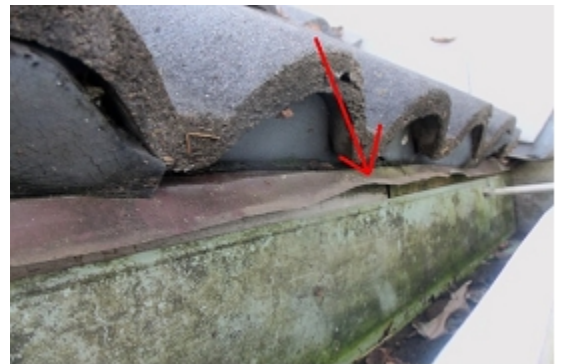
The metal eave drip edges are bent up and damaged in several locations around the roof.

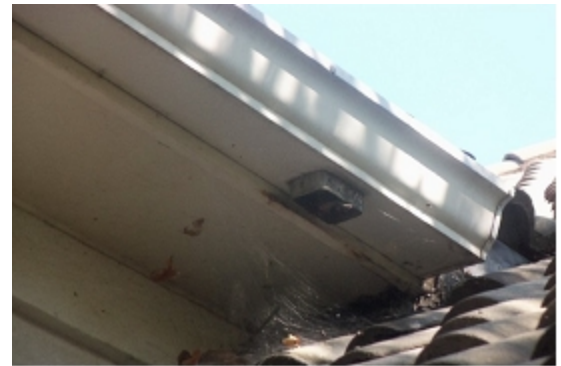
1. At the upper Southwest roof line on the south side there is a short gutter with the downspout flanged but there is not any type of elbow installed kick the water away from the soffit and wall area.
2. There is evidence at most of the inner and outer corners of the gutters that show evidence of leakage. These areas should be cleaned and resealed.

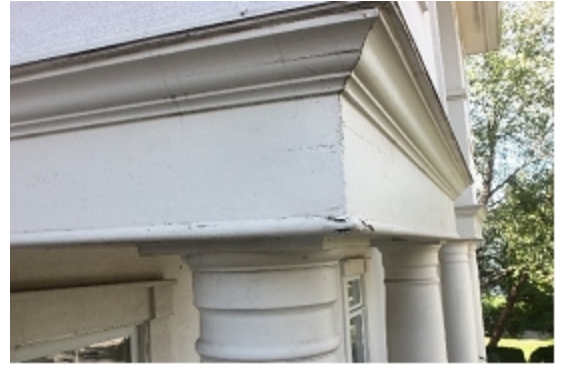
1. There is wood rot around the front porch fascia area above the columns. There is flat metal flashing above these areas that need the corners and overlaps caulked and sealed.
2. The west side exterior hose spigot needs the pipe flanged secured to the stucco. Be sure to caulk and seal around the flanged when completed.

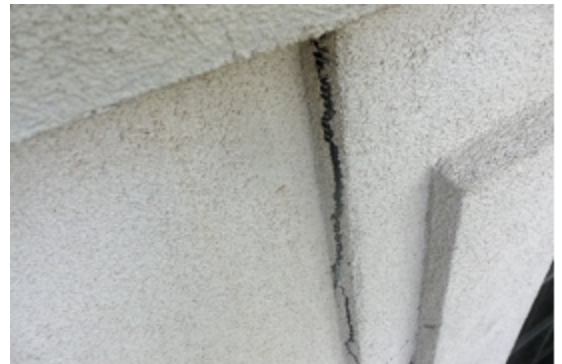
1. The stucco surfaces need repairs at just about every panel on the exterior. The corners of the stucco are cracked and opened up.
- There are horizontal cracks throughout the surfaces. These horizontal cracks hold water and that is what causes surface damage and also possible water intrusion issues.

A stucco company needs to come out and view all the surfaces of the stucco and bid proper repairs needed.

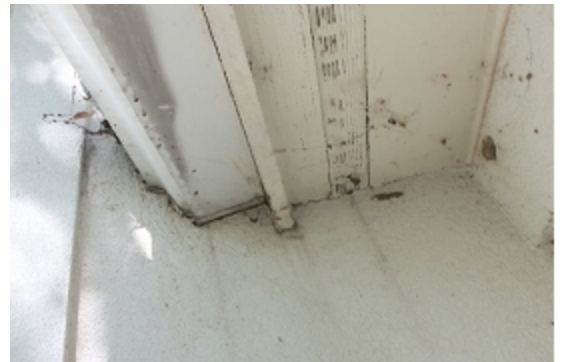
There is a gap between the kick out flashing in the stucco, so I don't know if this water issue was prior to this kick out flashings or for could still possibly be an issue.

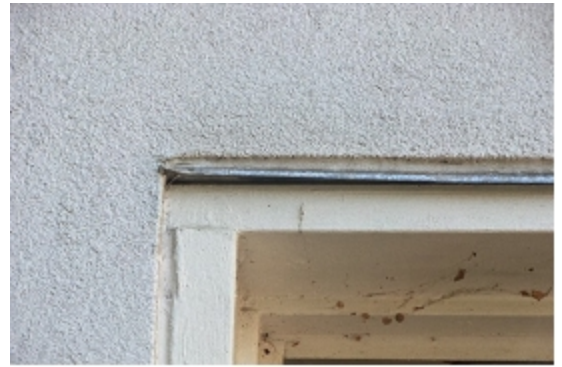
The Metal Z flashings above the garage vehicle door openings are raised in a few locations and need to be properly tapped down to prevent water getting under the flashings.

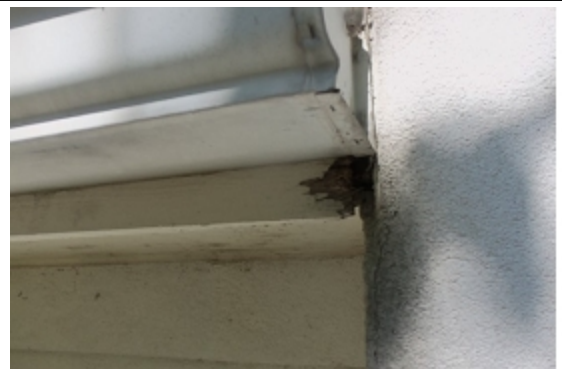
This damage fascia board is located on the south side of the Living room area.

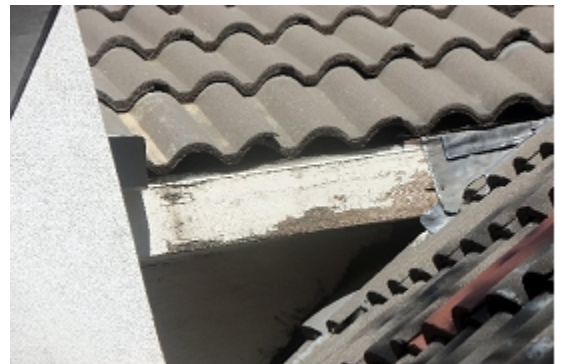
1. There are a few areas where the fascia boards are visible where there aren't gutters installed. The painted surfaces are deteriorated and there are some water damage caused by the roof tiles setting to far in from the eave edge. This picture is located on the south side above the kitchen area.

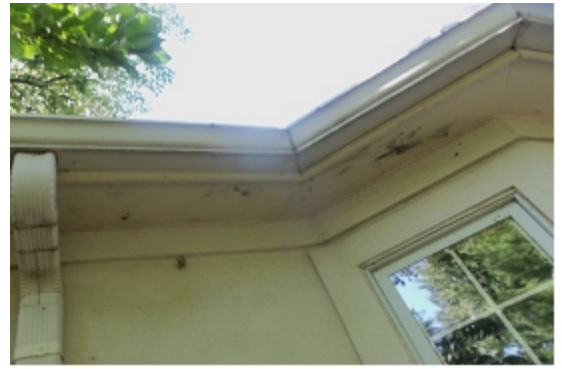
Here's another picture of the soffits with a lot of mold growth. All the soffits need to be ventilated.

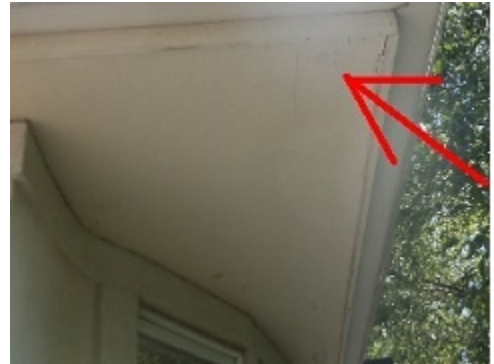
1. There are a couple corner soffit areas that has had water in the material is wavy.

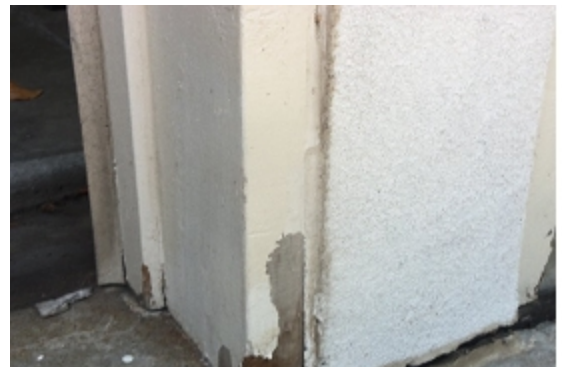
Most of the wood surfaces on the exterior need to be prepped and painted.

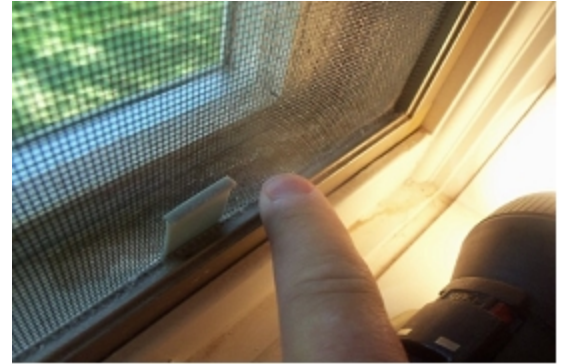
Master bedroom bath window at the toilet area show signs of wood rot at the bottom casement. Also at the north bedroom.
