RC Certified Inspections

Inspection Report

???? W. 117th St.
Leawood , KS
66211

Inspection date: 9/14/2015

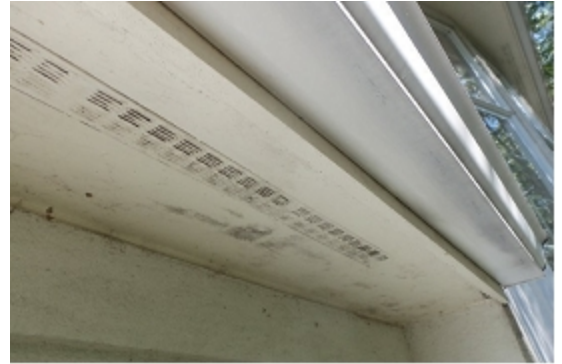
1. The soffits have narrow soffit ventilation, but most of it has been painted over.
2. There is mold growth on the surface of the soffits basically on all sides of the home which is normally an indication of improper soffit ventilation or soffits filled with insulation.

* I recommend that the soffit vents be removed to inspect the soffits and either blow out or clean out soffits and install new vents.

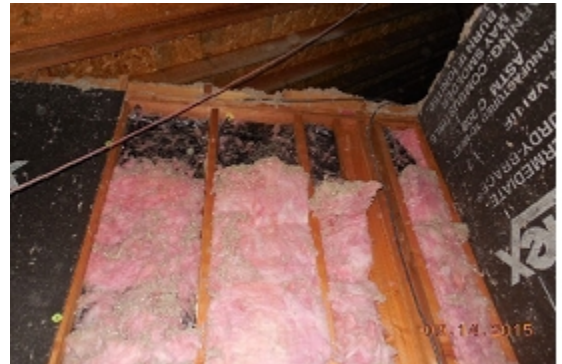
1. There is damaged and missing vertical wall insulation in the attic area above the master bedroom bath area.

2. The attic appears to have all blown in Cellulose insulation. I cannot tell if all the insulation was completely vacuumed and removed from the attic prior to installing this insulation. I am recommending that you receive documentation from the insulation company regarding what work was done in the attic.

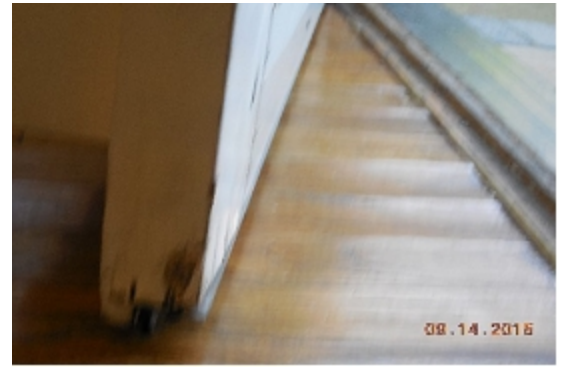
1. There is been water intrusion at the top of the door casement and Wood rot as noted.

2. The bottom of the door is rotted.

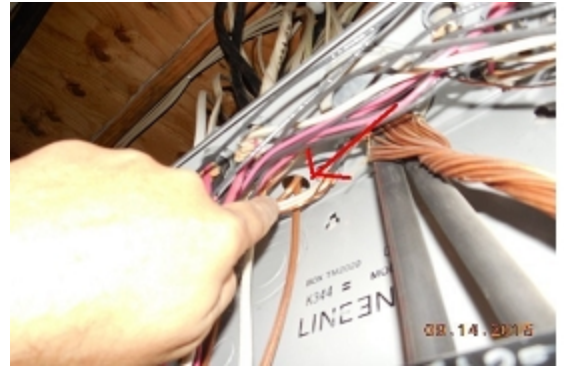
Cable Connectors Missing

1. North electric panel: Top left corner at the ground wires exiting a large knockout. This opening must be sealed with the cable connector per code.

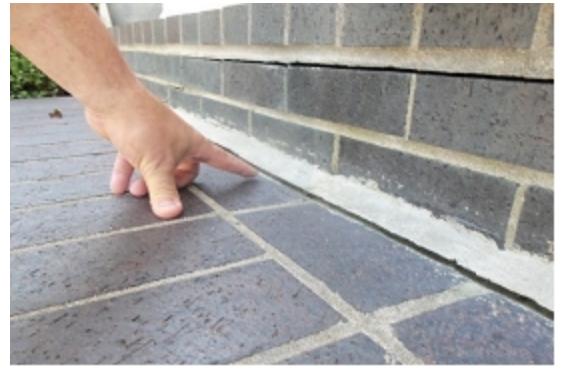
1. There are several of the brick mortar joints that need to be cleaned out and repaired (top pointing). There are cracked and open mortar joints and fungi growing through the mortar joints.

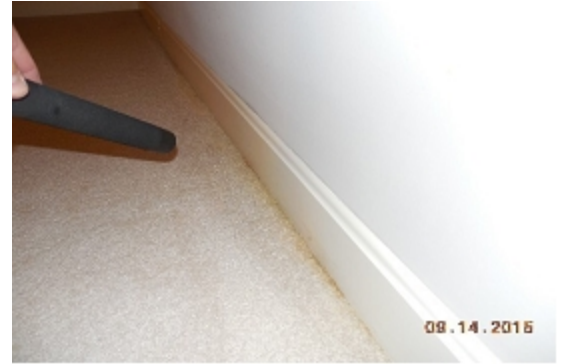
1. There is evidence of water intrusion in the main finished area along the south wall, at the southeast corner of the what bar area, at the west side Windows area, bedroom area at the northwest corner and along the north wall area. This was seen by the staining of the baseboard trim and also staining of the carpet along the baseboard trim. This does not necessarily mean that there's been water in the basement but with the poor drainage, gutters and downspouts on the exterior, allows water to migrate under the basement slab and where the basement slab in the foundation wall comes together will emit high humidity which causes these issues. ***** See the Mold Growth section in this report.

2. There is evidence of termite mud shelter tubes between the floor joists in the basement unfinished area which should be located under the dining room area. I did not find any structural damage though, so review the termite inspection report from Weavers Exterminators.

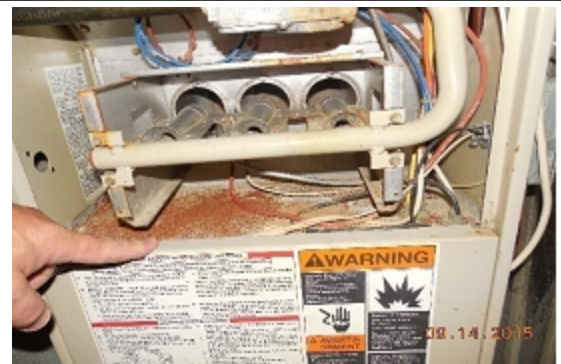
3. There is water staining and rusting in the furnace compartment at the burners and the blower area. This is caused by overflowing or a rusted out evaporator condensation drip pan. Continuous leakage onto the heat exchanger can cause cracks in pinholes.

2. Recommend replacing the air filter also.

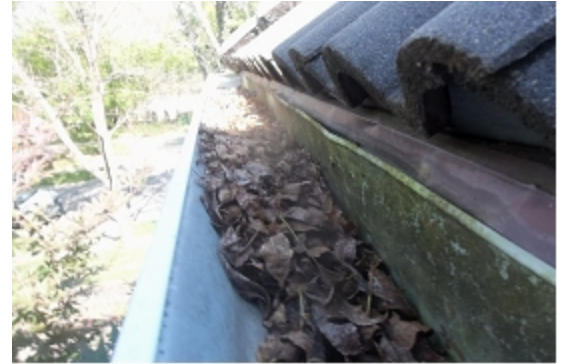
1. The gutters need to be cleaned out.
2. The gutter along the west side of the garage is not properly installed in conjunction with the eave metal drip edge. Both the eave metal drip edge and the back side of the gutter is bent up and the gutter sets out further than the drip edge which is allowing water to flow between the gutter and the fascia board. This can cause water intrusion to the interior as well as rot to the fascia board.
3. There are a few other areas were the gutter sets lower than the eave drip edge. At these areas flat metal flashing can be installed under the eave drip edge and run down into the gutter.
- 4.

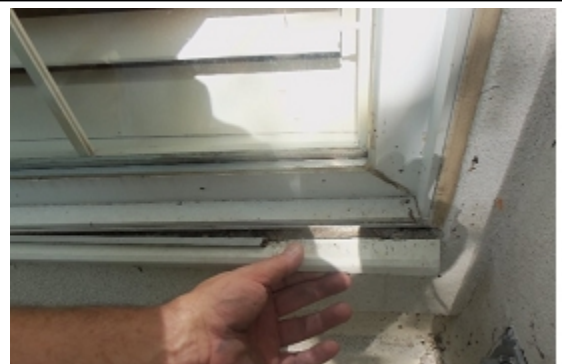
1. There are metal flashing installed under the Windows between the Windows in the stucco and everyone is loose and/or not installed properly. This is just a picture of one of them.

If the stucco surfaces was removed and the new material installed, then the blame goes back to the stucco company that did this last work.

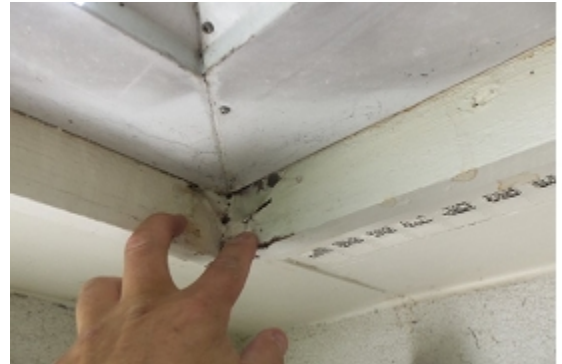
1. On the west side Southwest Corner area the fascia boards at and inner corner are rotted.
